The James Weldon Johnson Foundation 2022 Report

JAMES WELDON JOHNSON WRITING CABIN

Recreation/installation of missing window sash Replacement of cedar shake roof and copper flashing Fieldstone masonry repairs to chimney and foundation Repairs to wooden slab siding and trim; staining Change Order for digging soil from below the cabin and replacing with stone Additional structural work and exterior site view Site visits and tours

December 29, 2022

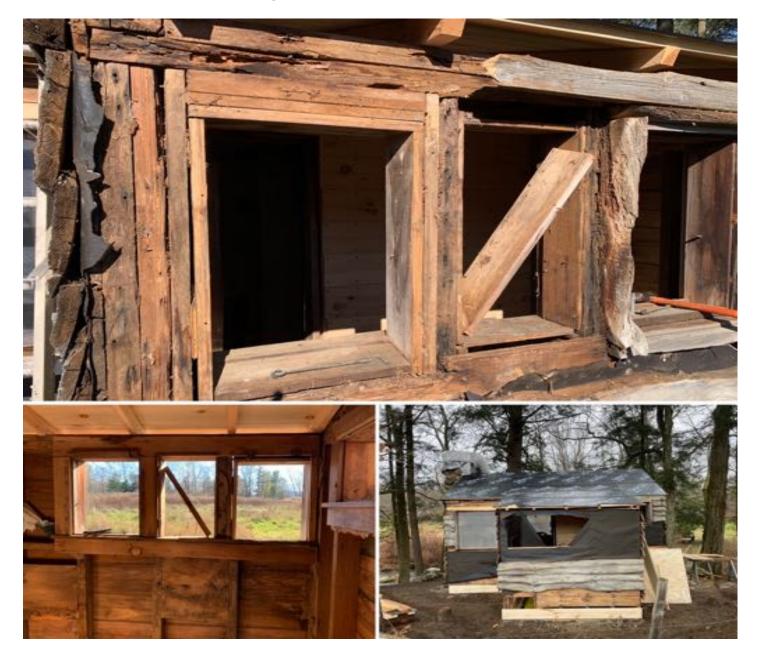
WRITING CABIN - SOUTH EXTERIOR

Recreation/installation of missing window sash

The windows will all be either restored or recreated to match, depending on the condition of each individual window. The small square awning windows have sash that are mostly intact and can be used as the pattern for millwork profiles. The awning sash are in poor condition but have enough material remaining to provide profile information. The larger double casements that show in historic photos are gone, but the photos show the muntin divisions, the hinging and other details. The window frames and trim themselves are mostly in good condition apart from maintenance and small repairs. The window sash will be restored and recreated in a specialty shop devoted to that purpose. Since the cabin was not heated and will not be heated apart from the small fireplace, the sash is single glazed and will remain as such. It remains possible to install storm sash, although none show in the early photos of the cabin. Metal fittings and hinges will match as nearly as possible the ones that can be seen either inside or in the photos. The built-in roller shades will be restored.

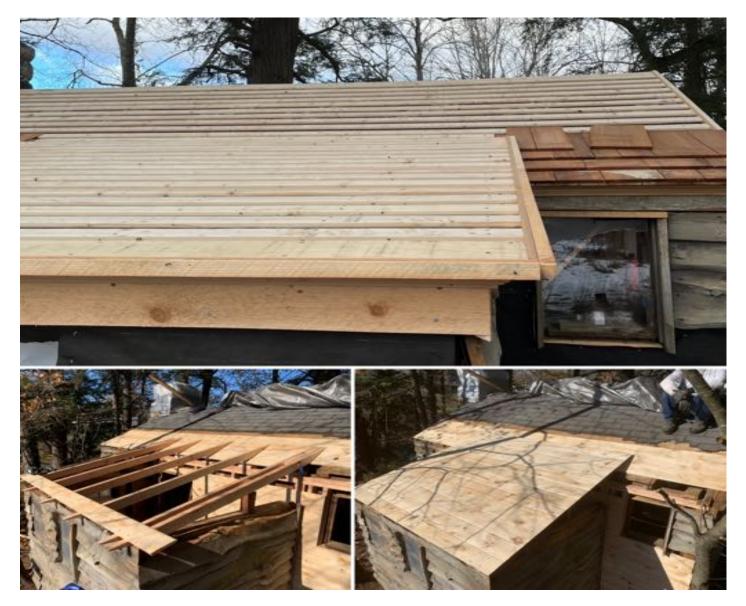
WRITING CABIN - UPPER VIEW

Replacement of cedar shake roof and leaded copper flashing

The original roof was cedar shakes on closely spaced wooden board sheathing on top of tongue-andgroove beaded board, with the beaded board fastened from above to the rafters and running at 90 degrees to the rafters. No roofing nails penetrated the beaded board when constructed. The roof is restored using a two-way ventilating wood grid on top of building paper ("tarpaper") laid over the beaded board, with the lower members parallel to the rafters, directly on top of them and secured through the beaded board to them. On top of those new strips, which run from the eaves to the ridge, a second set of strips at 90 degrees are placed, to serve as spaced board sheathing for the new cedar shakes. The shakes are nailed to these spaced boards.A continuous ventilation slot running along the eaves just below the shakes are formed by holding the eaves trim below the bottom of the overhanging shakes approximately 1/2 inch. The slot is continuously screened to keep insects and vermin out. A continuous ridge vent allows the roofs to vent at the highest point of the roof. The 15-lb. building paper will provide protection of the beaded board from any leaks in the shakes, as will the ventilation grid below the shakes.

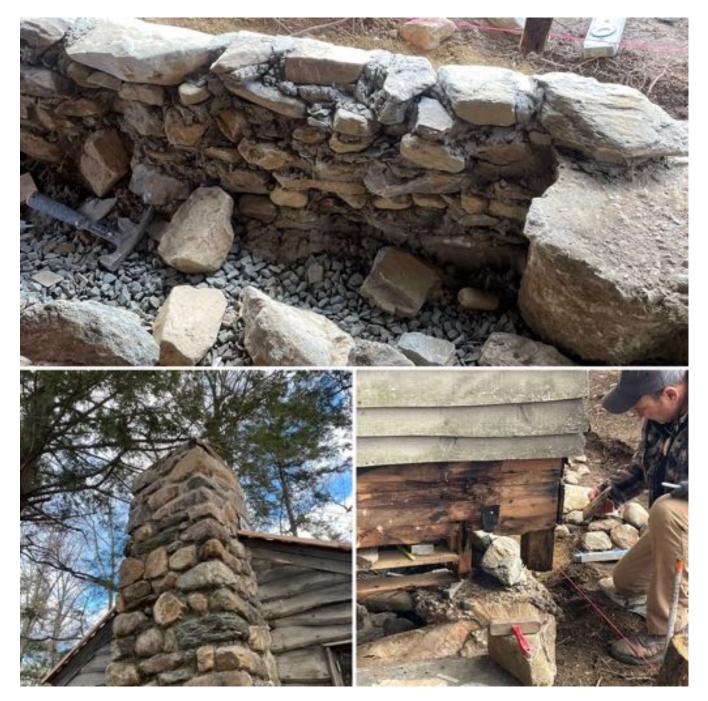
WRITING CABIN - FOUNDATION AND CHIMNEY

Fieldstone foundation and chimney masonry repairs

The fieldstone foundation and chimney are in generally good condition and required repair in places. The original stones were mostly where they fell and have been collected for reuse. They are reset using a mortar like 1 part Type I or II Portland cement: 2 parts hydrated lime: 8 to 9 parts bulked sand, with small quartzite inclusions to match various areas of the existing. Weakened joints were deeply scraped and repointed. The introduction of small amounts of Portland cement into masonry mortar was underway at the time of the cabin's construction and may explain why the masonry is still in relatively sound condition.

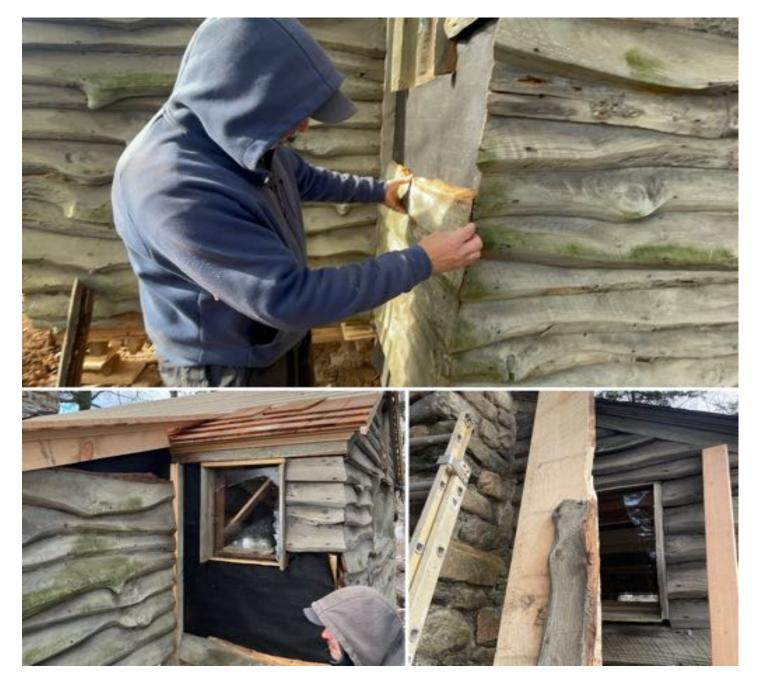
WRITING CABIN - WOODEN SLAB SIDING

Repairs to wooden slab siding and trim; staining

The wood slab siding is mostly intact, as is the trim, but has areas needing repair. The species is believed to be white cedar, and has been matched for repairs. It has held up extremely well, in part because the amount of direct sun on the cabin was limited by tall well-spaced surrounding evergreens. Yet the trees did not create an overly moist environment either, which would tend to compromise the building's outer services with moss and discoloration due to mildew and fungus. Most damage that has occurred to the siding has been either a result of proximity to grade or invasion by pests such as bees and raccoons. The finish of the exterior wood siding and trim will be linseed oil. A light coating of linseed oil will rejuvenate the cedar, which is naturally oil-infused wood.

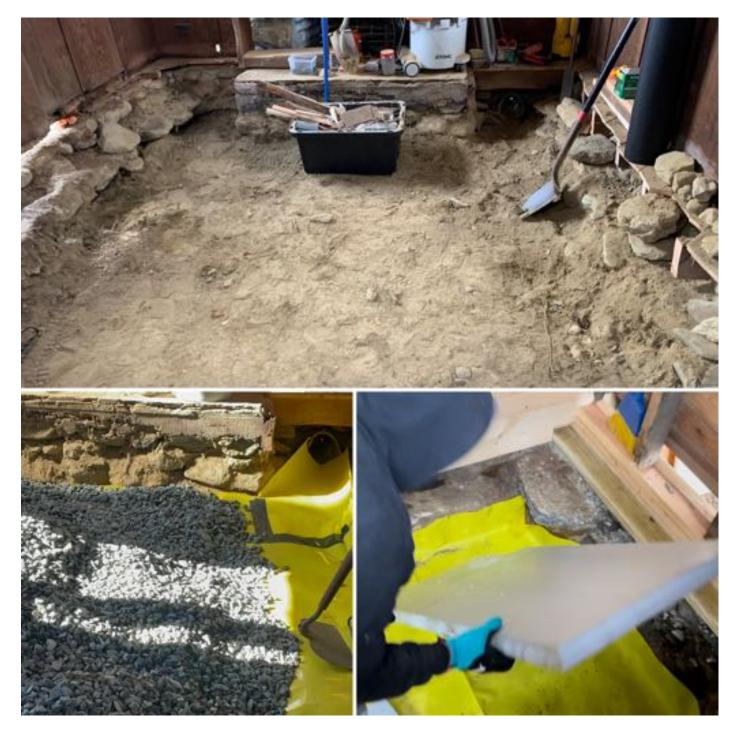
WRITING CABIN - SOIL, VAPOR BARRIER, STONE, FOAM INSULATION UNDER FLOOR JOISTS

The grade has risen since construction (circa 1926) due to the foliage cycle of its wooded site. The grade has been lowered and sloped away to increase the distance up to the wood siding. Additional exterior site work was needed to bring the grade down in order to create a ventilation space under the floor joists. This includes additional structural work to reframe walls with rotted studs; replacing rotted floor joists; rebuilding the bathroom foundation; and modifying the rest of the foundation in order to accept the floor joists.

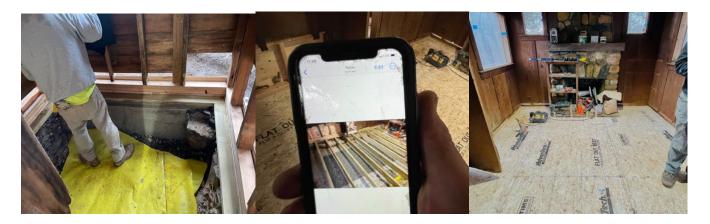
EXTERIOR SITE VIEW

Additional structural work to replace rotted floor joists; sub-floor to support exterior structure
